LONG-TERM STORABILITY OF PROPELLANT TANKAGE

TECHNICAL REPORT AFRPL-TR-71-113

NOVEMBER 1971

AIR FORCE ROCKET PROPULSION LABORATORY
DIRECTOR OF LABORATORIES
AIR FORCE SYSTEMS COMMAND
UNITED STATES AIR FORCE
EDWARDS, CALIFORNIA

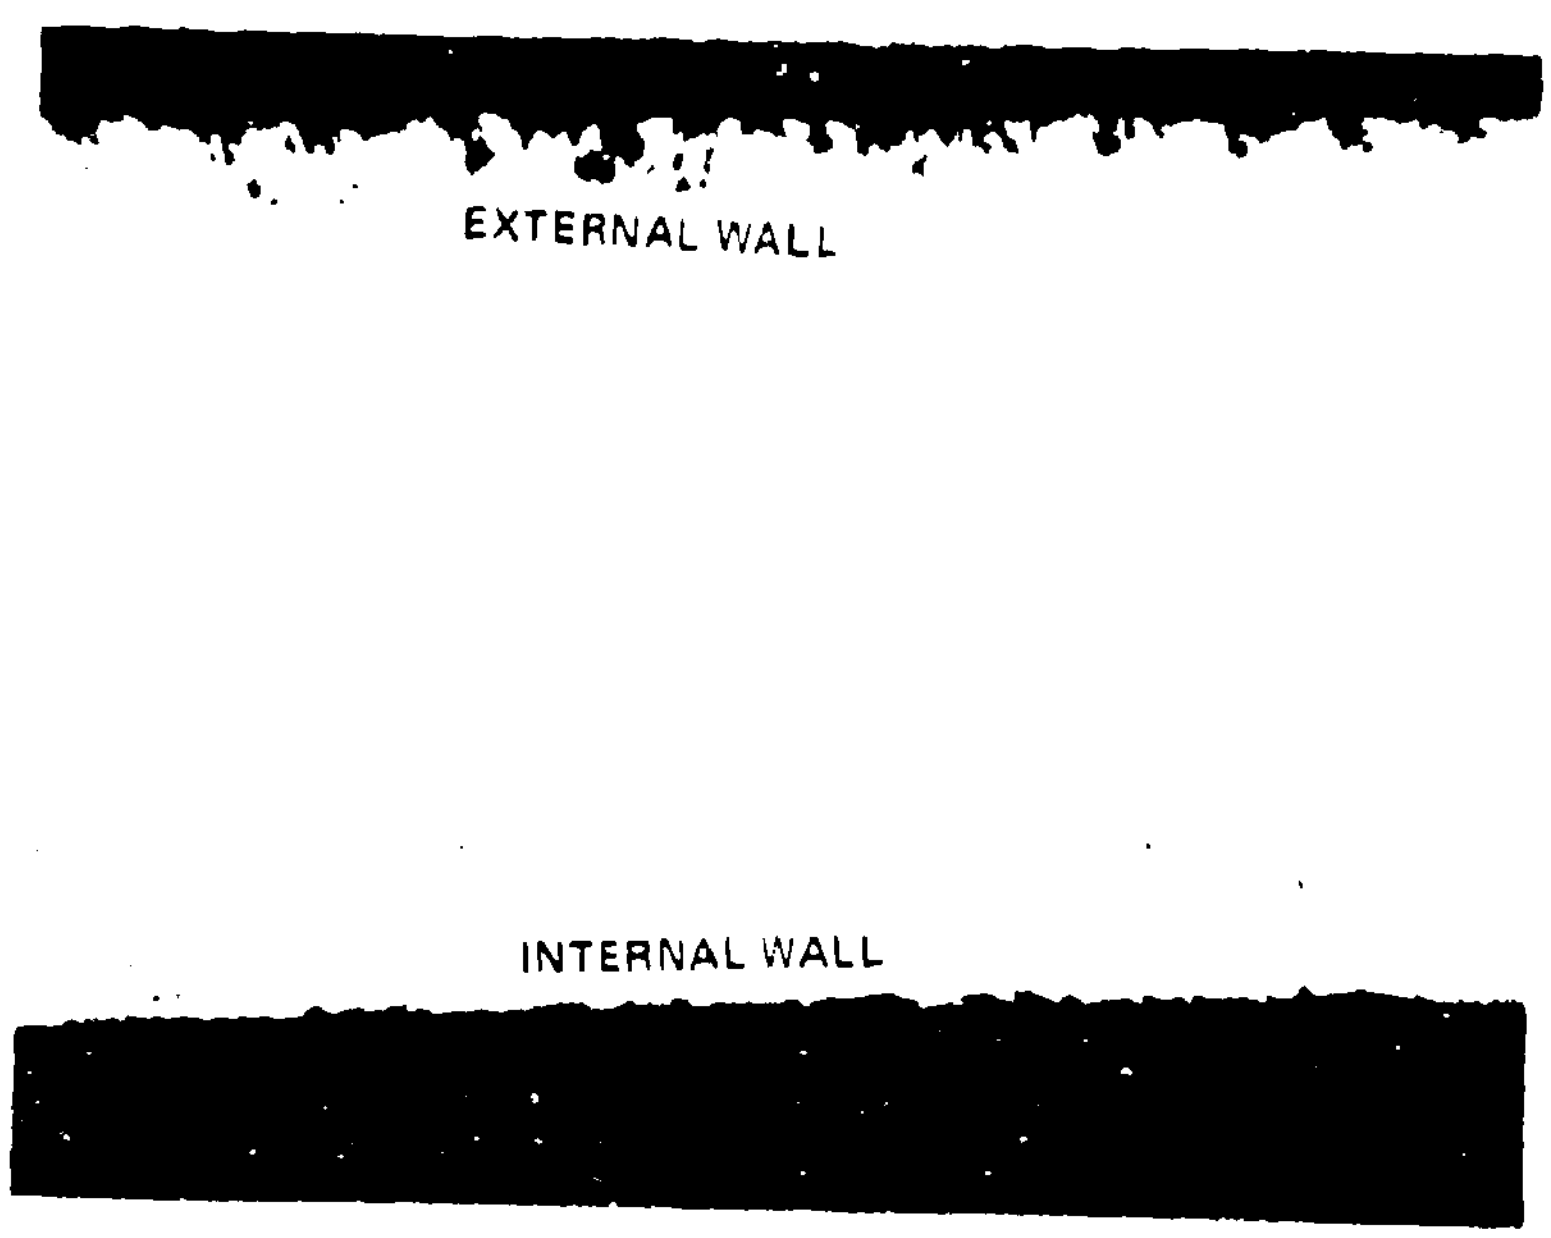
Figure 5. Cross Section of Thin Wall of [illegible] Casing Showing Pitting Corrosion on Exterior Wall (20X)

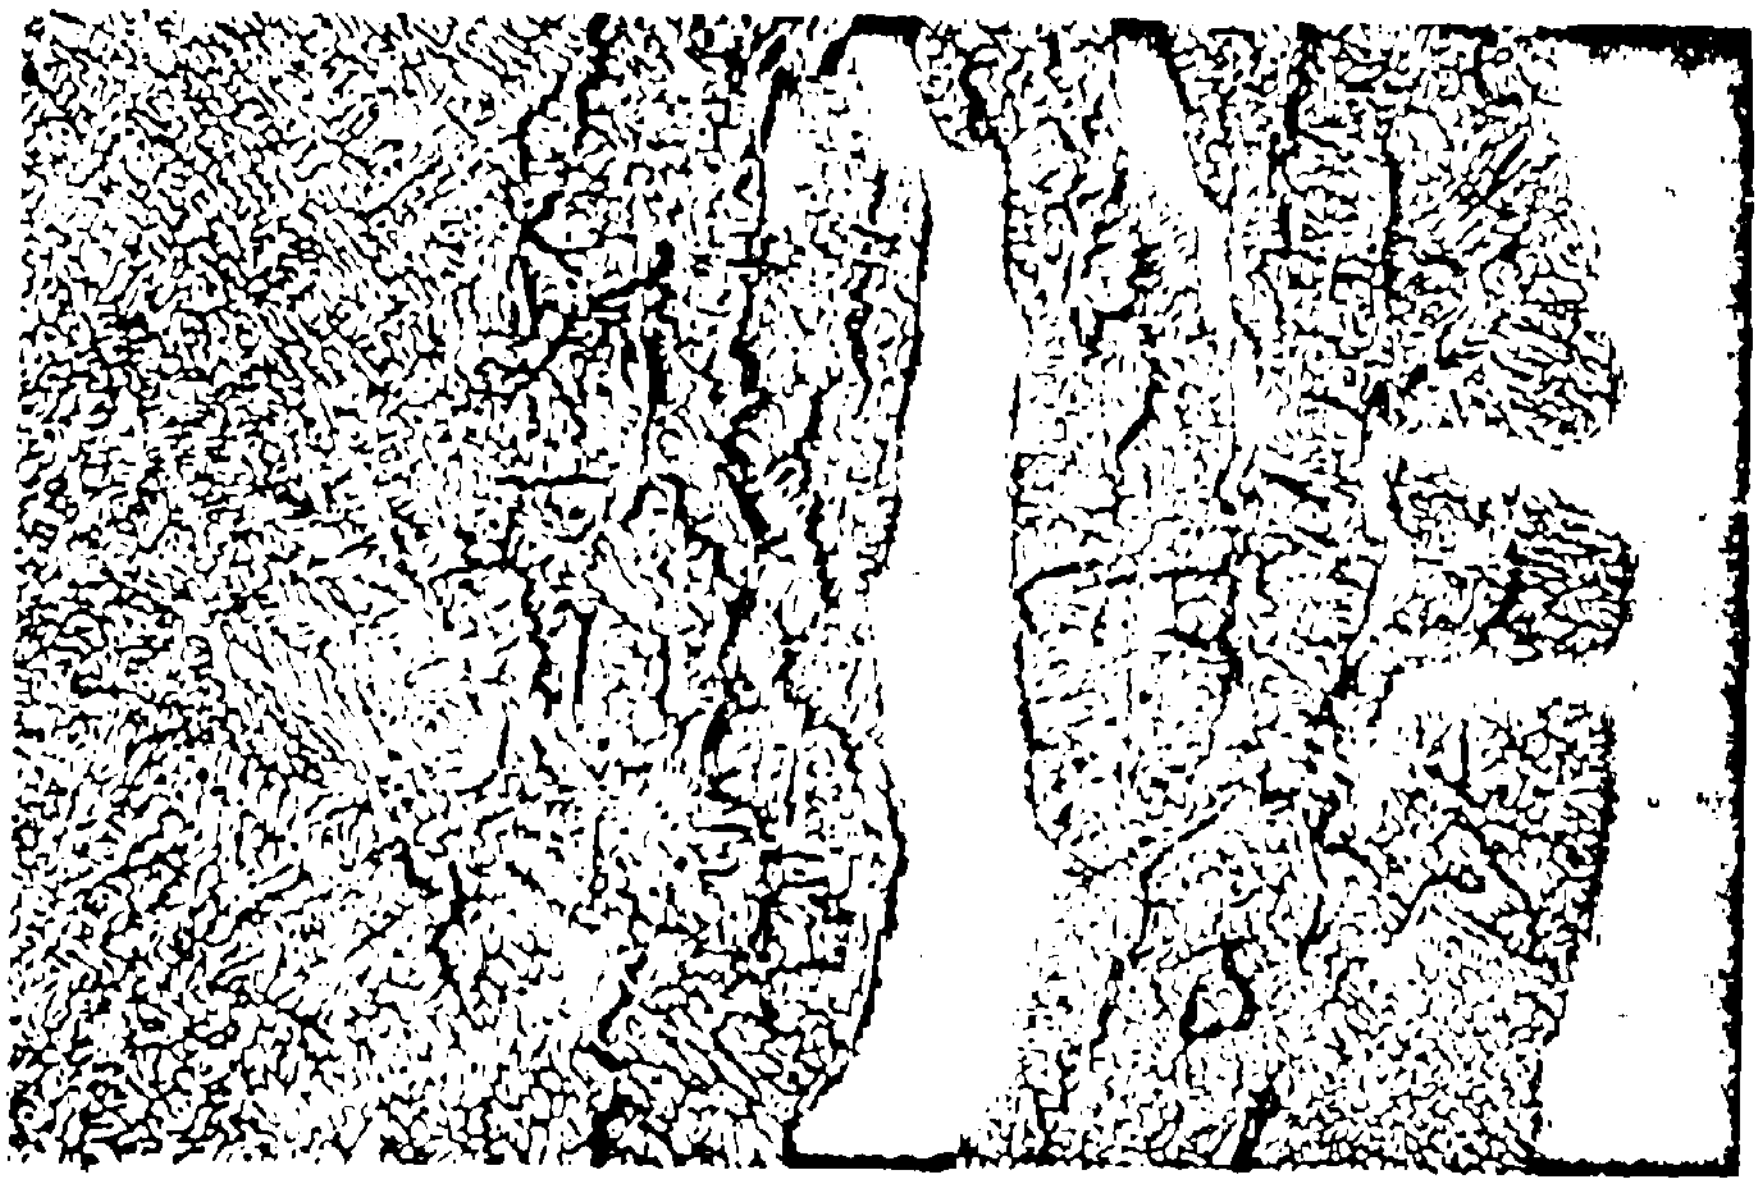
Fig. 2 Spec.No. 243092 Neg. 181287A Mag. 100X Etch: Keller's

Shows the corroded condition of one of the cracked welds.

Shows the attack, at a higher magnification, extending along the dendritic boundaries.

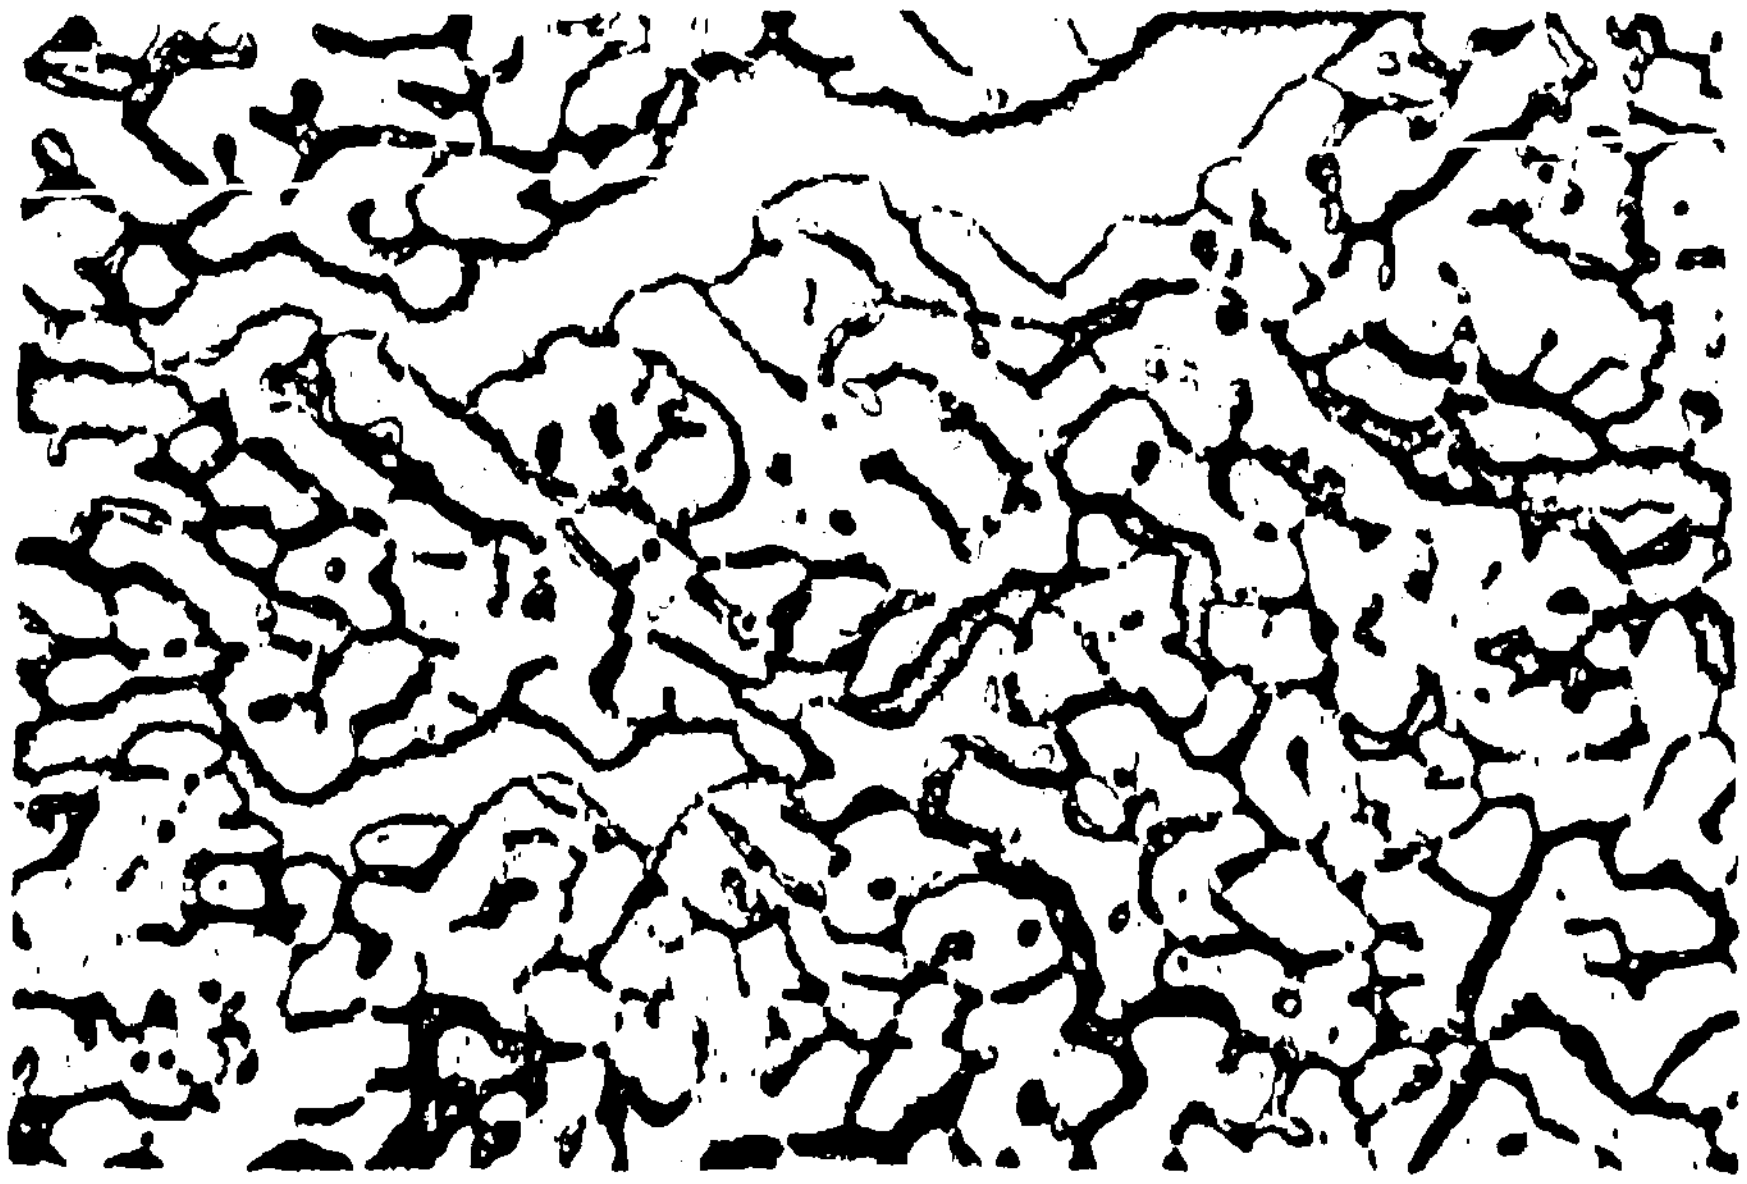
Fig. 3 Spec.No. 243092 Neg. 181288A Mag. 500X Etch: Keller's

Shows the coring present in the corroded region of the lug end weld.

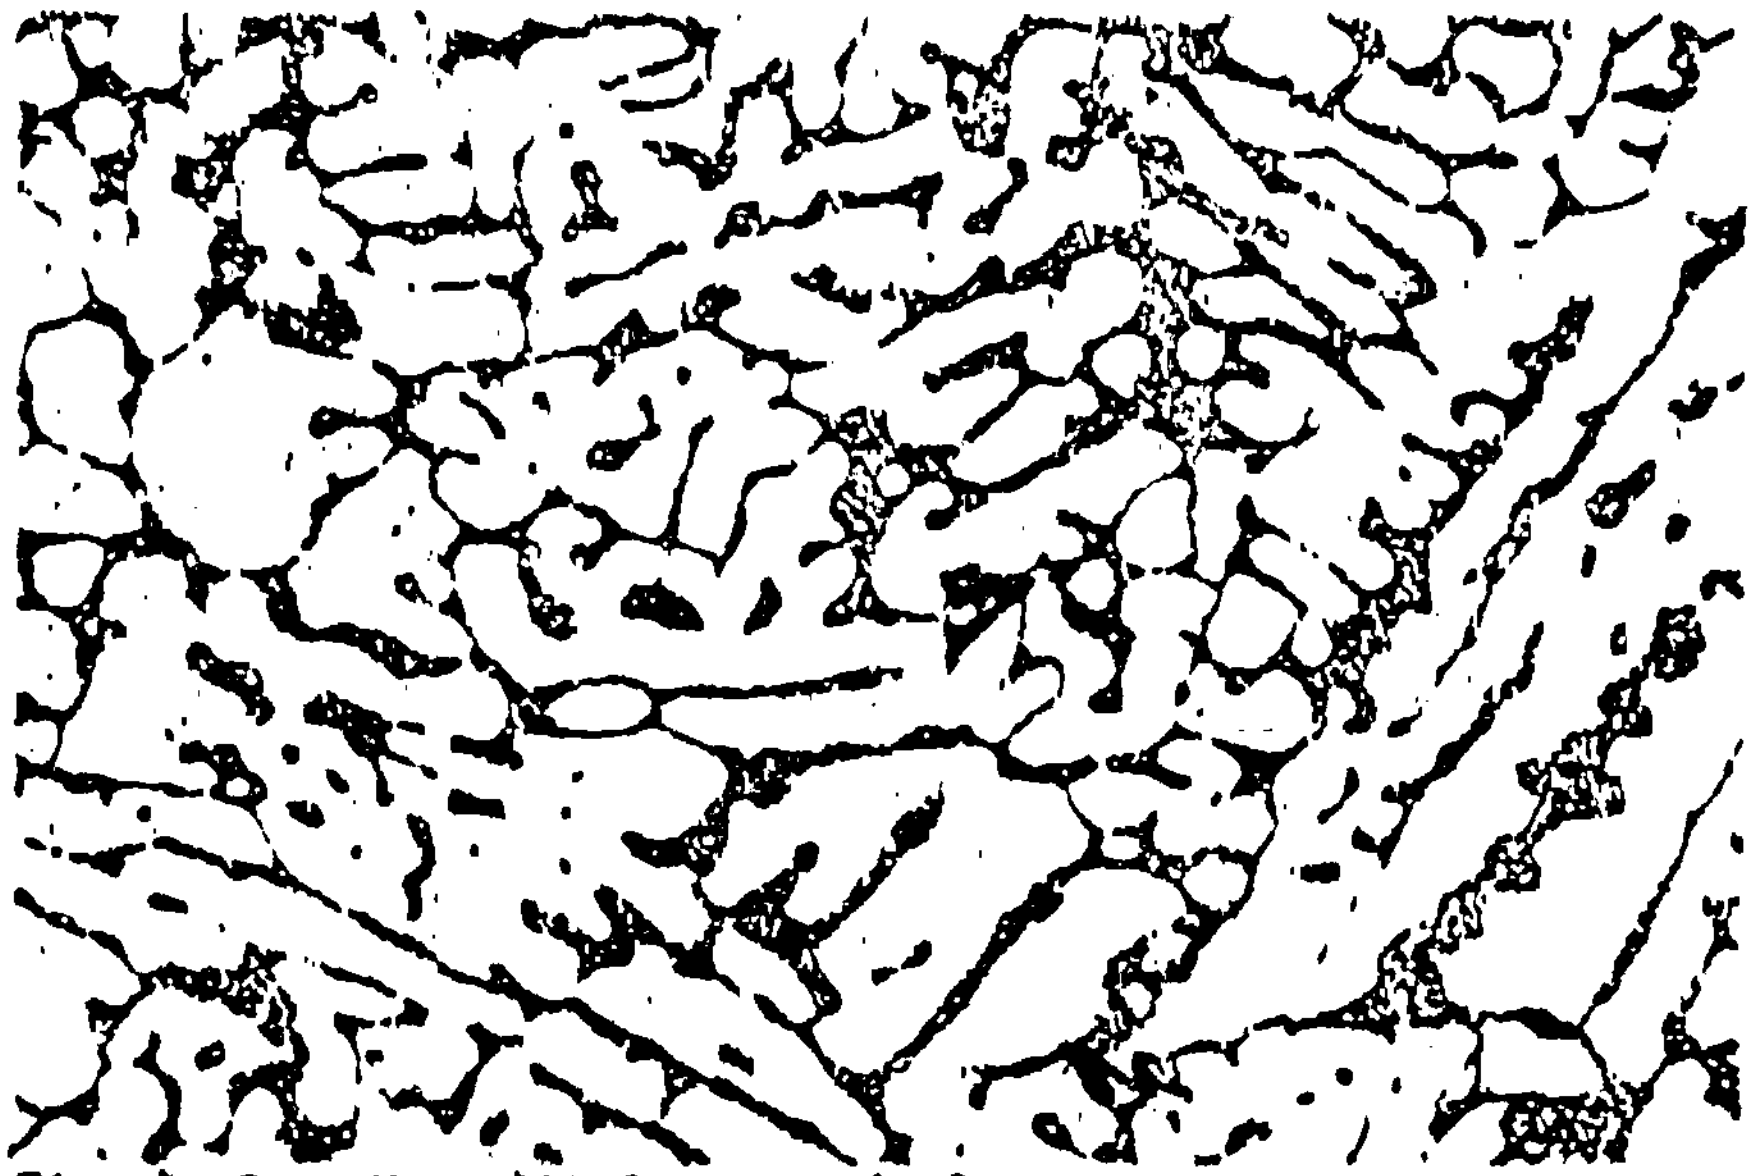
Fig. 4 Spec.No. 243092 Neg. 181289A Mag. 500X Etch: Keller's

weld bead but also showed a surface layer having a typical 4043 alloy weld structure as illustrated by Figure [illegible]. This uncorroded region may have been in a start-stop region since one area showed a sharp line of demarcation between the body of weld with coring and a cover area of 4043 alloy as illustrated by Figure 5.

Shows a weld structure representative of a typical 4043 alloy bead.

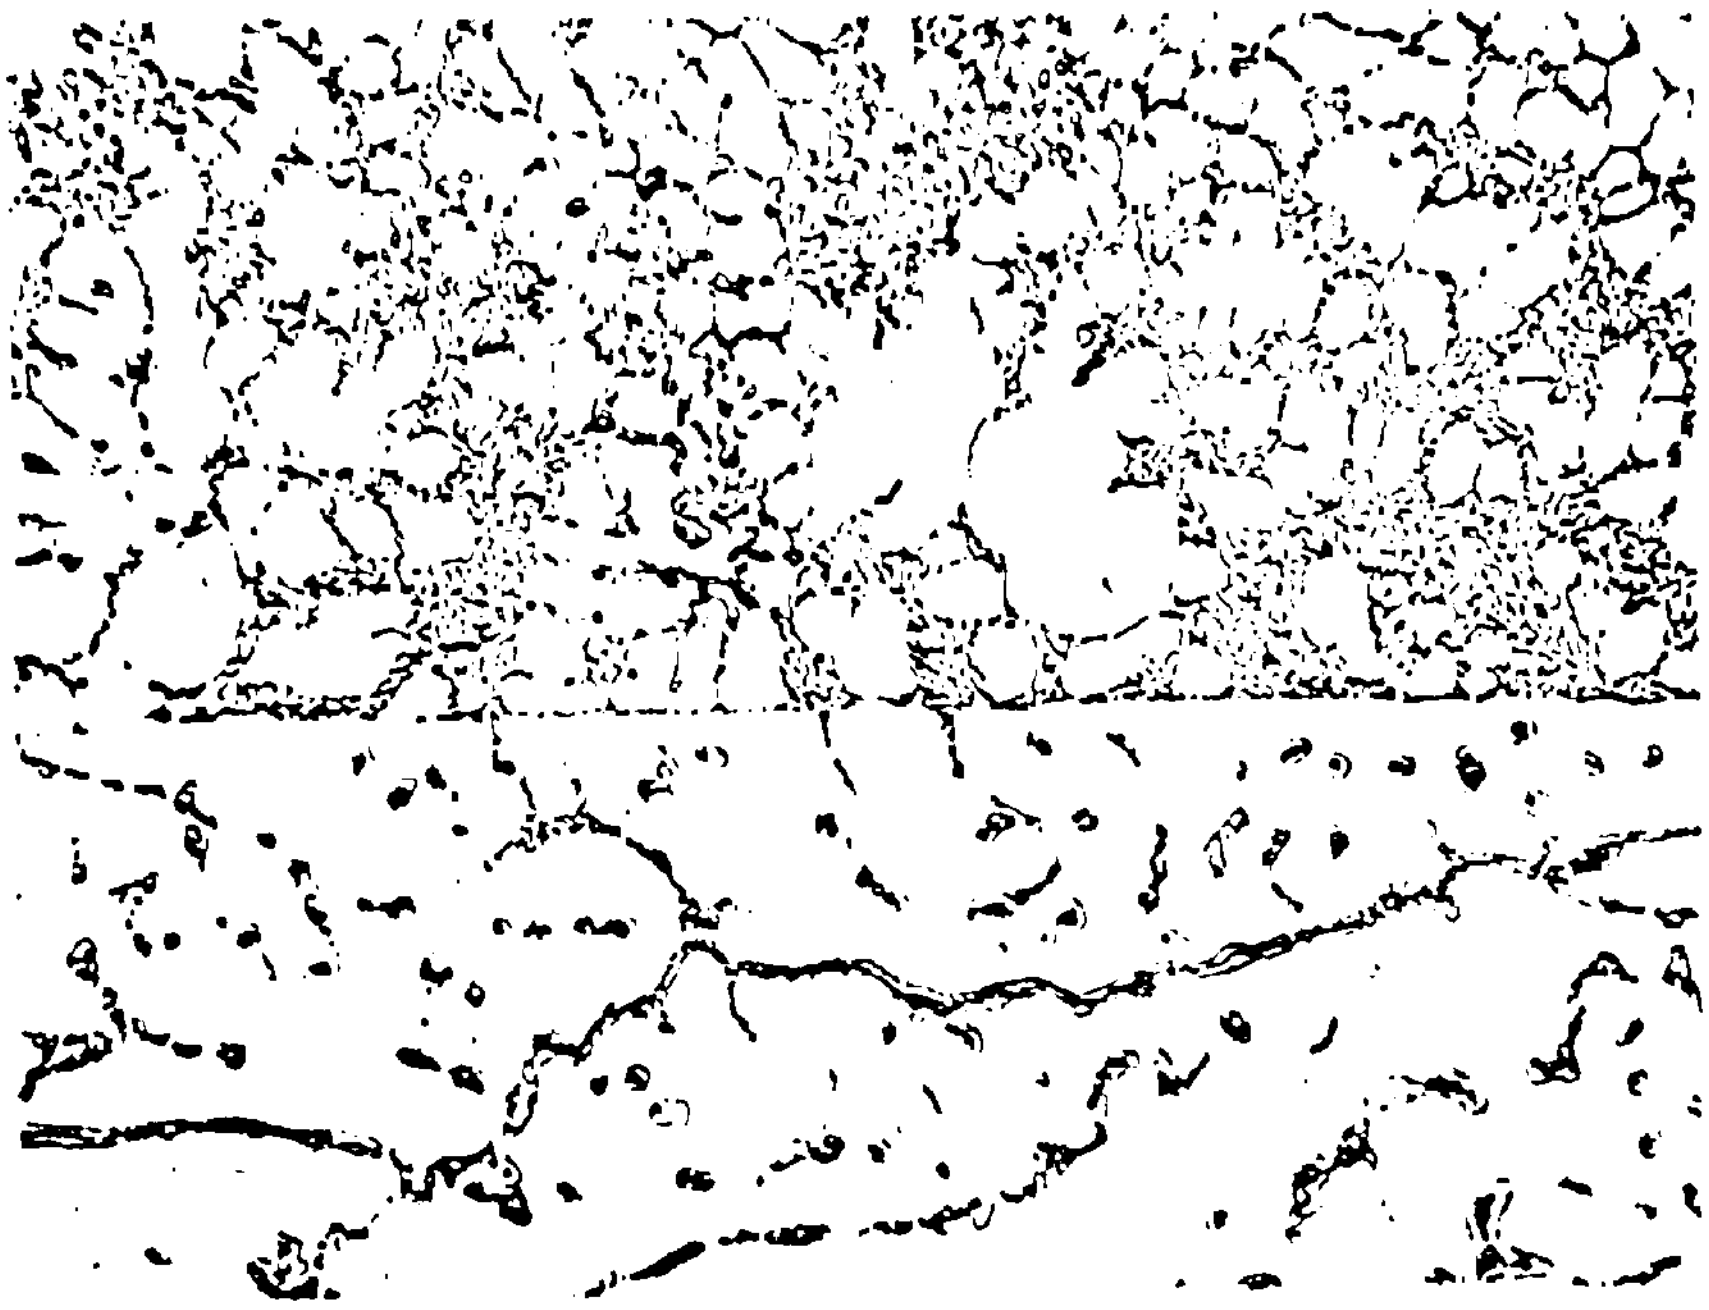
Fig. 5 Spec.No. 243092 Neg. 181290A Mag. 500X Etch: Keller's

Shows aluminum-silicon alloy structure covering a portion of the dilute 4043 weld metal.
